Bureau of Mines Report of Investigations/1984

# **Hand Dismantling and Shredding of Japanese Automobiles To Determine Material Contents and Metal Recoveries**

**Report of Investigations 8855**

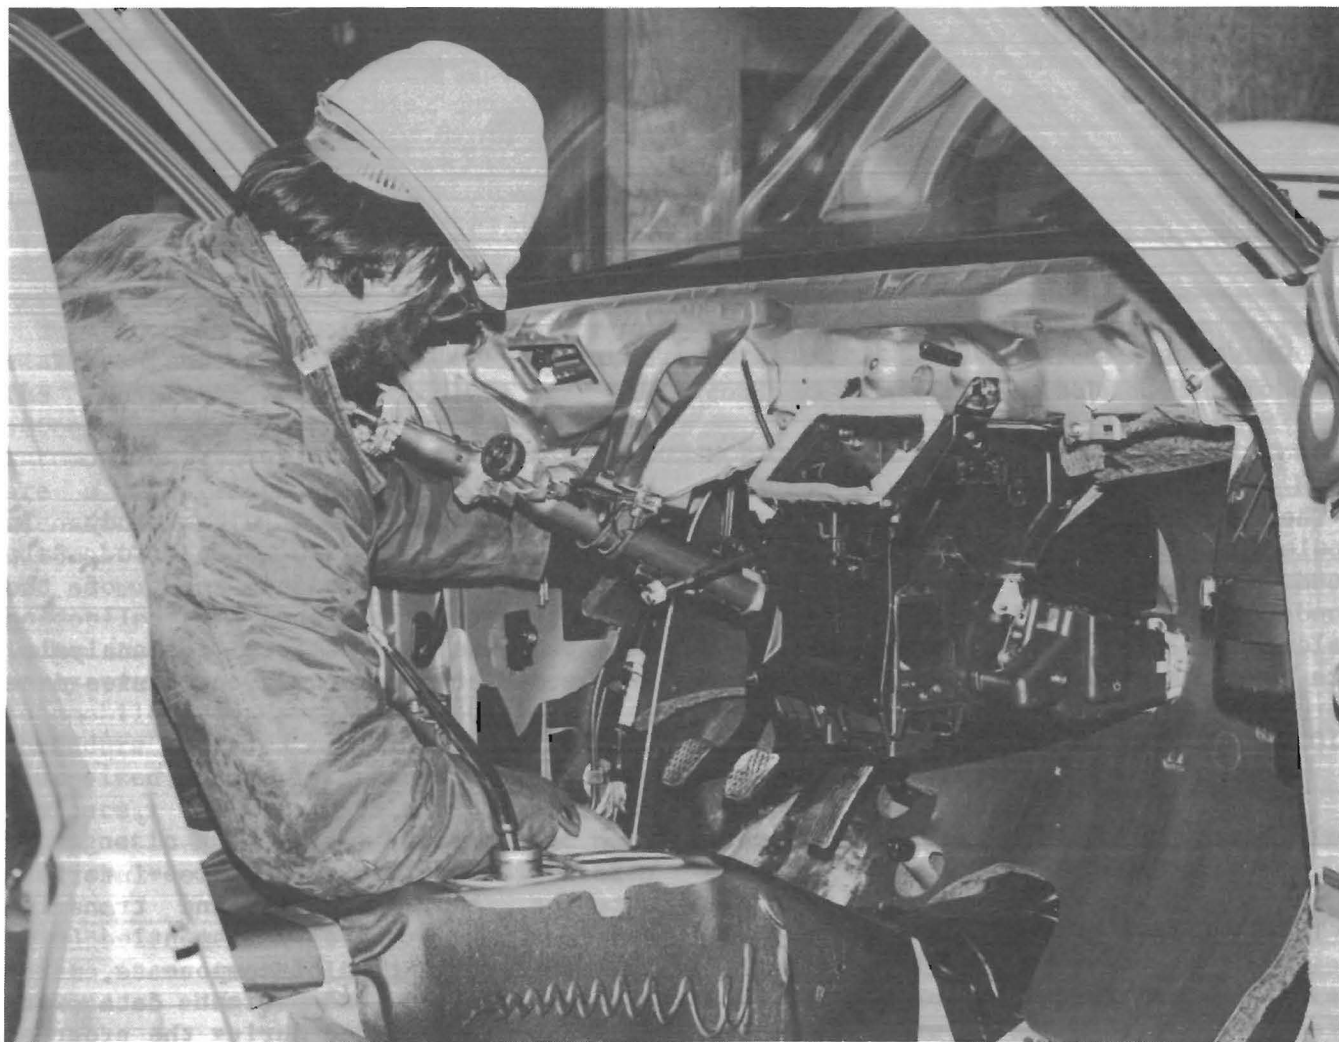
FIGURE 2. - Dismantling the 1981 Honda Accord.

Each area of the automobile--interior, exterior, body, engine, and transmission--was systematically dismantled (fig. 2). Identification of components, materials, location, and weight data were continuously recorded during the progress of the work. Electronic components were removed from the automobiles as complete units, and weight data were obtained

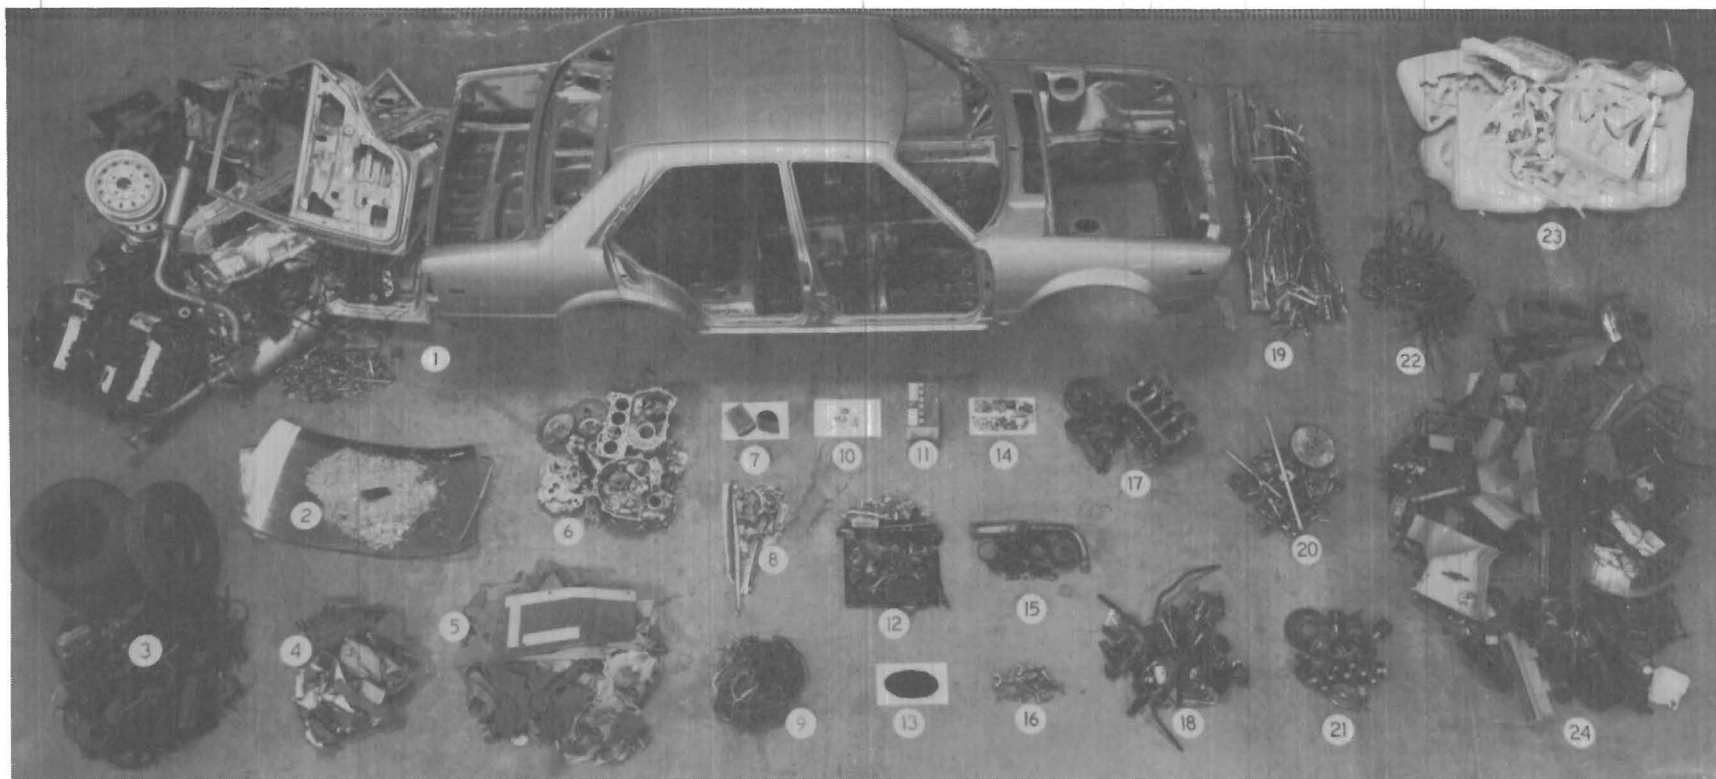
| 1. Light iron | 10. Lead | 18. Heavy iron |
| 2. Glass | 11. Battery | 19. Chrome-plated steel |
| 3. Rubber | 12. Brass | 20. Hardened steel |
| 4. Vinyl | 13. Charcoal | 21. Cast steel |
| 5. Combustibles | 14. Circuit boards | 22. Spring steel |
| 6. Aluminum | 15. Stainless steel | 23. Polyurethane foam |
| 7. Catalytic converter | 16. Forged steel | 24. Plastic |
| 8. Zinc | 17. Cast iron | |
| 9. Coated copper wire | | |

FIGURE 3. - Dismantled and categorized 1981 Honda Accord.

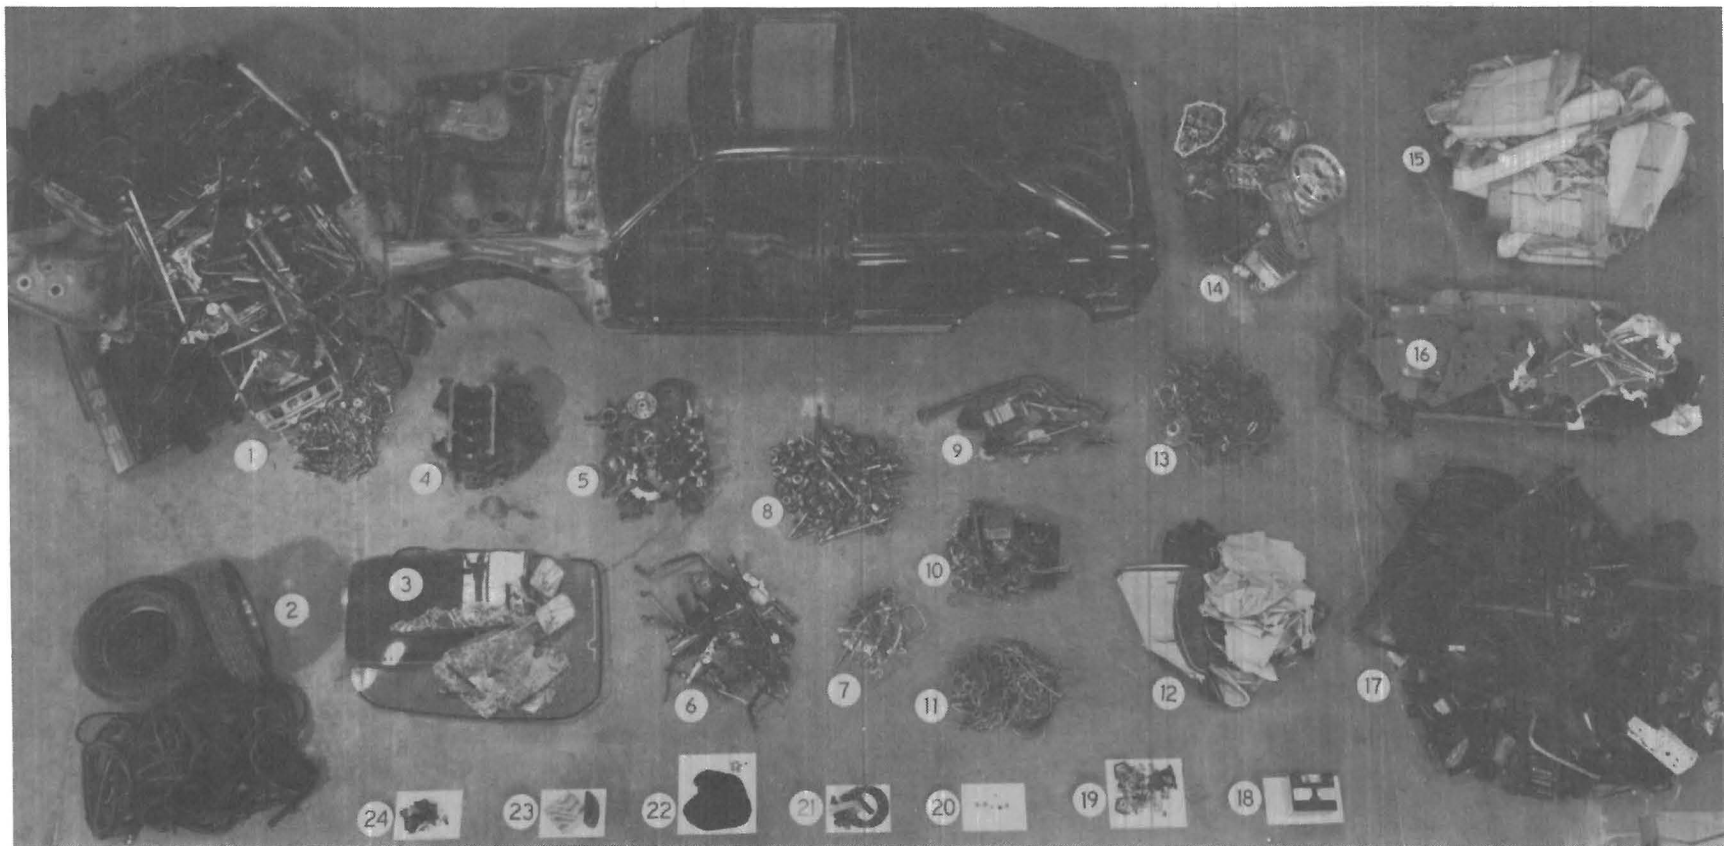
| 1. Light iron | 10. Copper and brass | 18. Battery |
| 2. Rubber | 11. Coated copper wire | 19. Zinc |
| 3. Glass | 12. Vinyl | 20. Lead |
| 4. Cast iron | 13. Spring steel | 21. Asbestos |
| 5. Cast steel | 14. Aluminum | 22. Carbon |
| 6. Heavy iron | 15. Polyurethane foam | 23. Ceramic<br>(catalytic converter) |
| 7. Chrome-plated steel | 16. Combustibles | 24. Ceramic |
| 8. Hardened steel | 17. Plastics | |
| 9. Stainless steel | | |

FIGURE 4. - Dismantled and categorized 1981 Toyota Tercel.

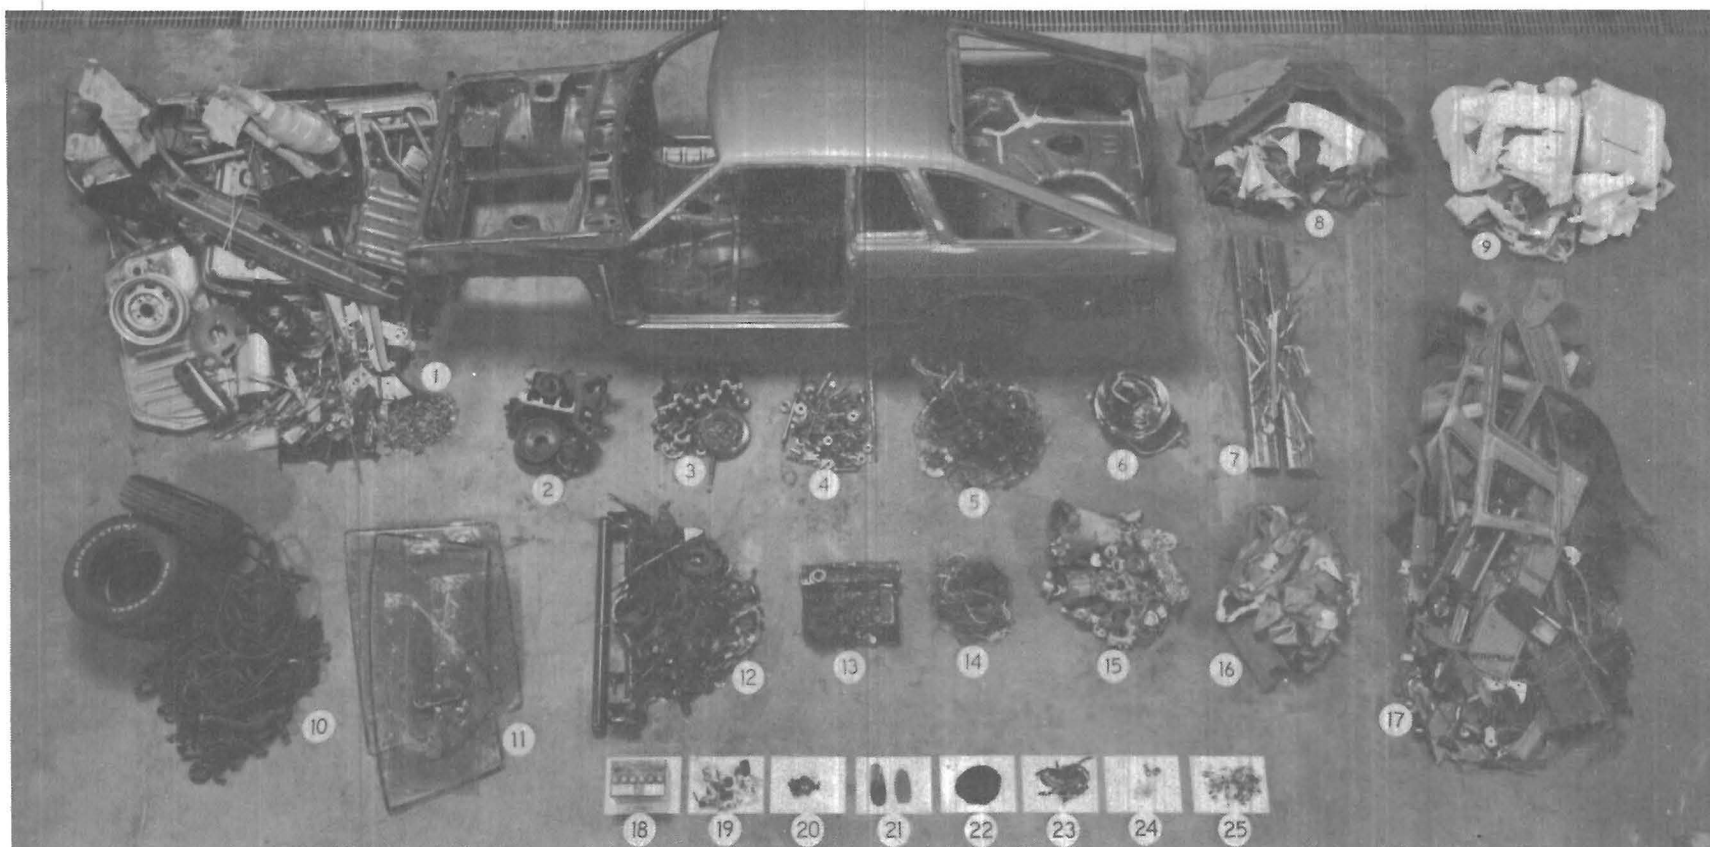
| 1. Light iron | 10. Rubber | 19. Electrical components |
| 2. Cast iron | 11. Glass | 20. Ceramic |
| 3. Cast steel | 12. Heavy iron | 21. Ceramic (catalytic converter) |
| 4. Hardened steel | 13. Brass and copper | 22. Carbon |
| 5. Spring steel | 14. Coated copper wire | 23. Asbestos |
| 6. Stainless steel | 15. Aluminum | 24. Lead |
| 7. Chrome-plated steel | 16. Vinyl | 25. Zinc |
| 8. Combustibles | 17. Plastic | |
| 9. Polyurethane foam | 18. Battery | |

FIGURE 5. - Dismantled and categorized 1981 Datsun 210.

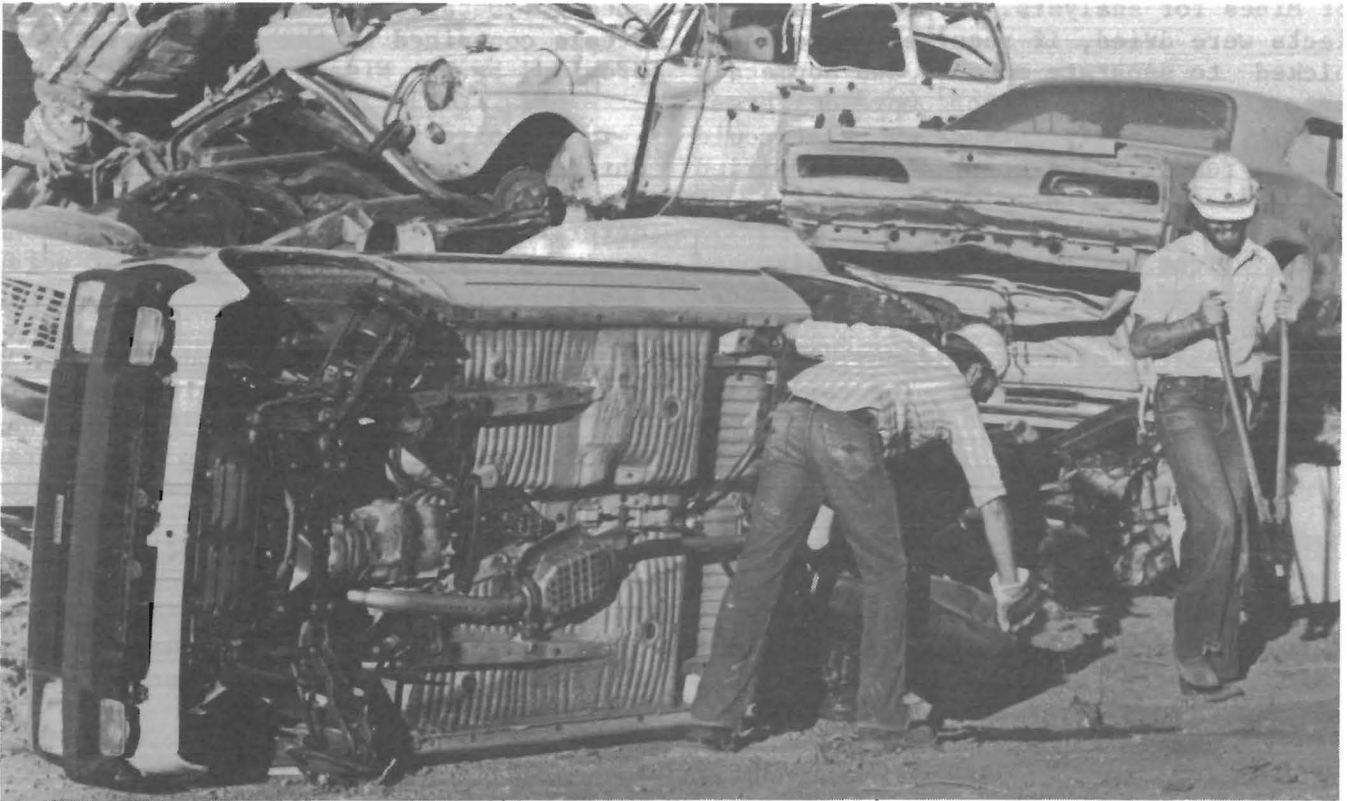
FIGURE 7. - Removing gas tank of 1981 Toyota Tercel prior to shredding.

Automobile weights were obtained at the shredding site both before and after preparation for shredding. Preparation included removing the gasoline tanks (fig. 7), batteries, tires, and wheels. The shredding mill, transfer conveyors, dust collection systems, and processing classifiers were purged before shredding the test automobiles to remove residual metals and nonmetals hung up or trapped in the system during production operation. Paired automobiles were fed into the shredder (fig. 8), one behind the other. Two metal products and six reject stream discards were collected in containers, weighed, and taken to the Bureau

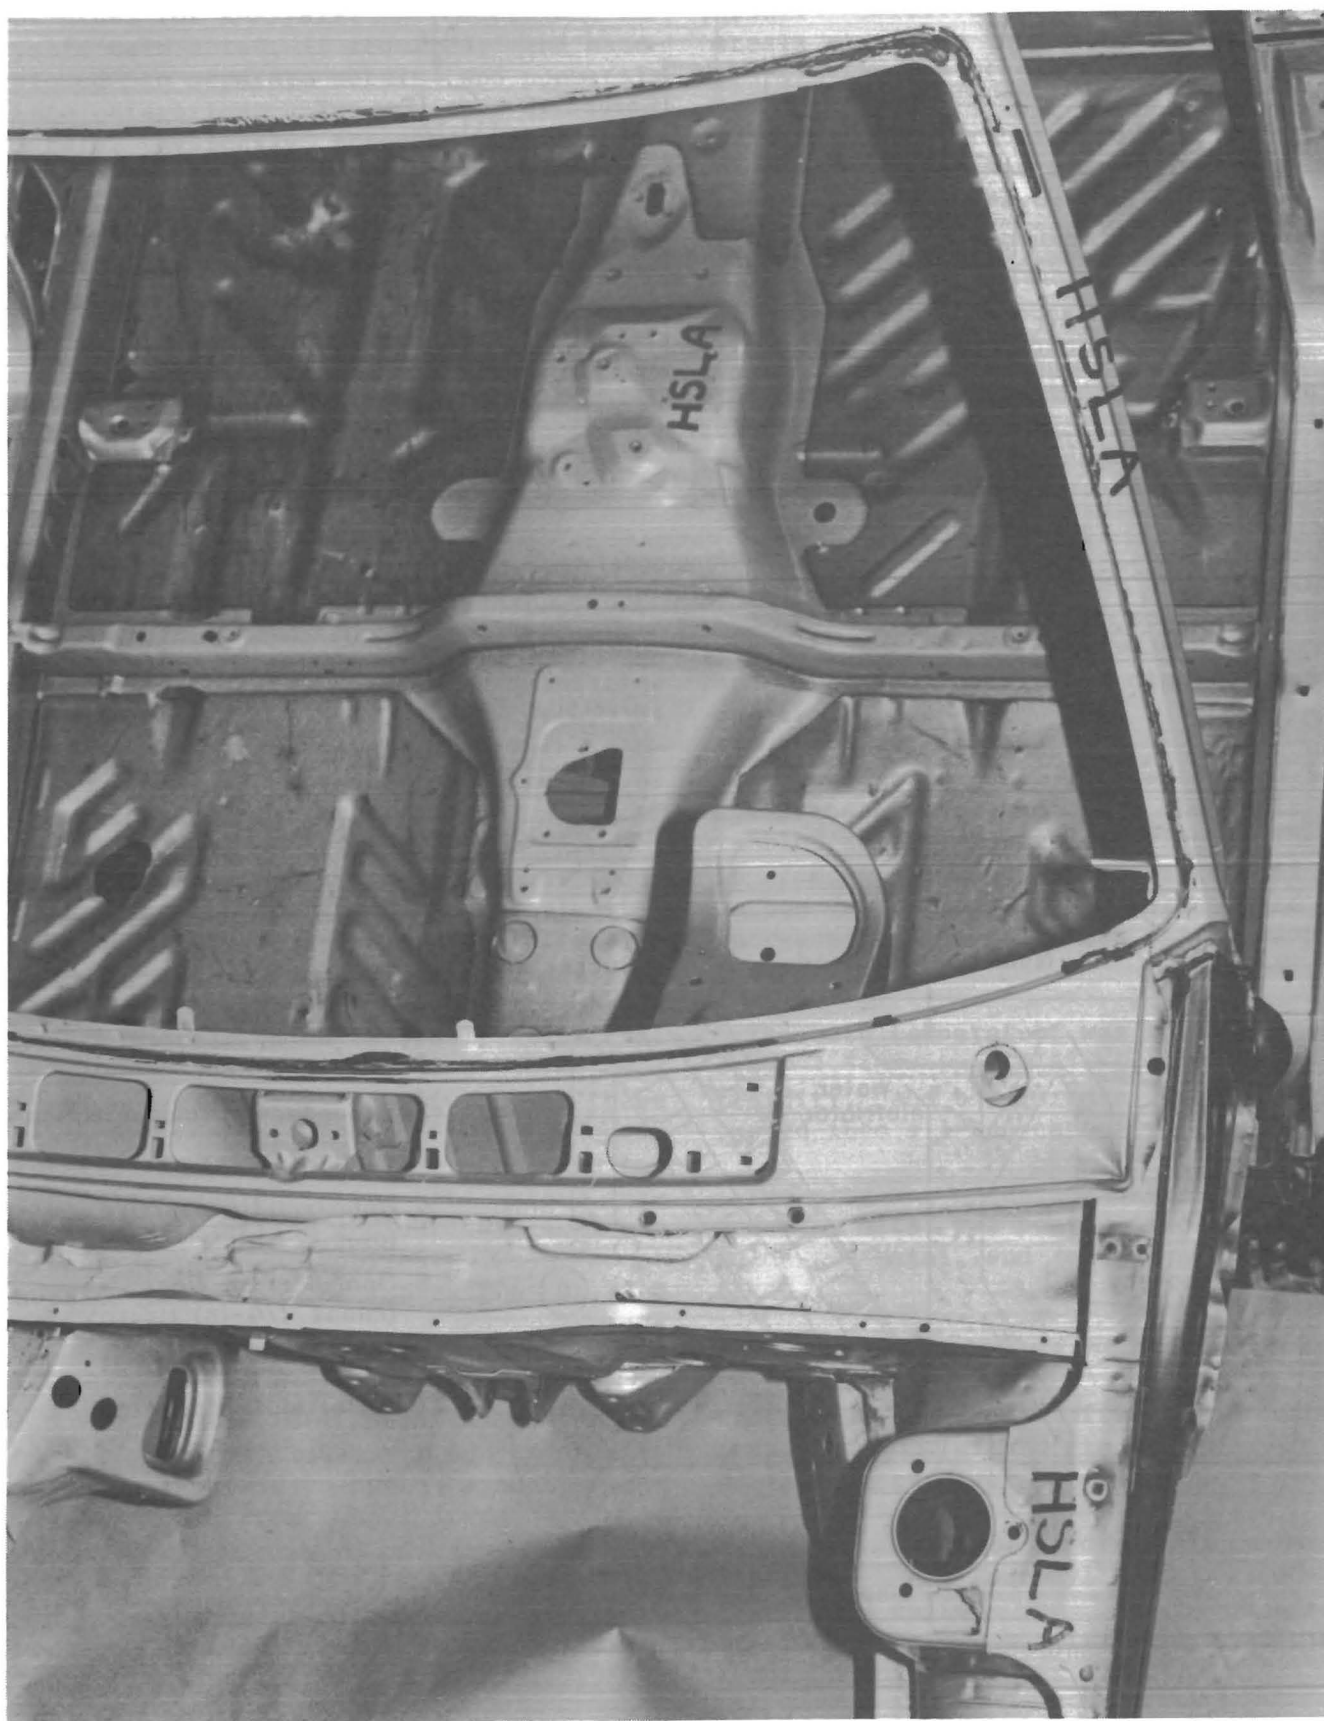
FIGURE 10. - HSLA steel application in 1982 Nissan Sentra.

The 1982 Nissan Sentra is the only automobile in the completed study to contain HSLA steel in significant quantities as shown in figure 10. HSLA steel is used to reduce the weight of the automobile as well as increase the strength of the structural supports.
